**Flood Control Project Maintenance  
Levee Inspections**

**Fall 2019 Levee Maintenance Deficiency Summary Report**

**San Joaquin River Basin**

**Flood Control Project Maintenance  
Levee Inspections****LMA District Cover Sheet****Fall 2019 Levee Inspection Results****Reclamation District No. 2031 Elliot**

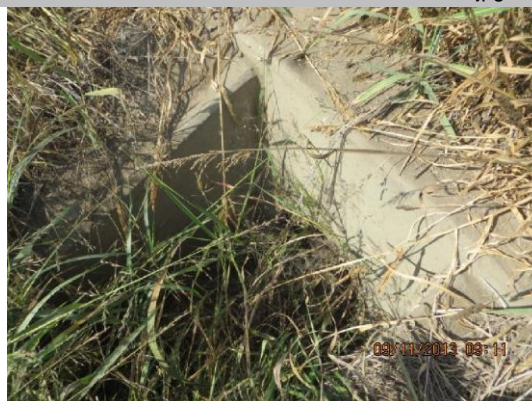
Photo 1 of 2 : UCIP\_FA\_2019\_20024\_33924.jpg

LM Start	0.35	Rating **	A/W	Issue No.	973
LM End	0.35	Issue Type +	Ma	Location *	
Category	Supplemental			GPS Latitude/Longitude	
				Start	End
Item	DRAFT DWR UCIP LMA Responsibility			37.705932 °	37.705932 °
				-121.157985 °	-121.157985 °
DWR ID	20437				
Comment Code					
Inspector Comment					
DS_ID:20437					
FS_ID:20024					
EP_NO: N/A					
Repair Type: No Action Needed					
Crossing Status: Found					
UCIP Comments:					
FIELD_STRUCT_DESC: 24-inch corrugated metal drainage pipe through the levee, 3.5 feet below the crown. Concrete U-shaped headwalls on both ends. Flap gate on the waterside (WS) end. Installed by USACE in 1966. [Additional Reference(s): DWR Levee Log, 2005. USACE San Joaquin O&M Manual 4, June 1968, (HLM 0.36)].					
FS Date: 9/11/2013

Concrete headwall on LS slope.

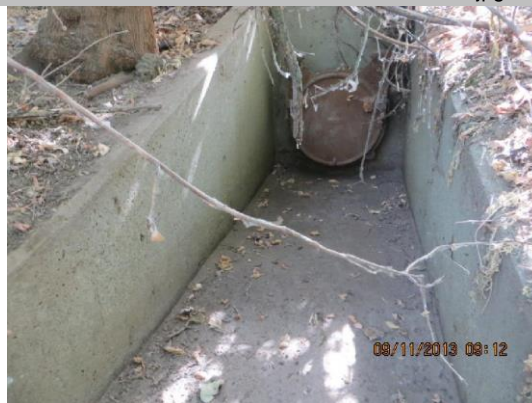
Photo 2 of 2 : UCIP\_FA\_2019\_20024\_33923.jpg

Concrete headwall and flapgate on WS toe.

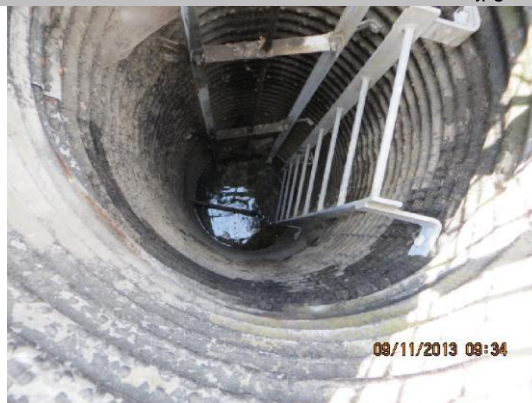
Photo 2 of 3 : UCIP\_FA\_2019\_20044\_33941.jpg

LM Start	0.56	Rating **	A/W	Issue No.	974
LM End	0.56	Issue Type +	Ma	Location *	
Category	Supplemental			GPS Latitude/Longitude	
				Start	End
Item	DRAFT DWR UCIP LMA Responsibility			37.703323 °	37.703323 °
				-121.159771 °	-121.159771 °
DWR ID	20439				
Comment Code					
Inspector Comment					
DS_ID:20439					
FS_ID:20044					
EP_NO: N/A					
Repair Type: No Action Needed					
Crossing Status: Found					
UCIP Comments:					
FIELD_STRUCT_DESC: 15-inch corrugated metal drainage pipe through the levee, 9 feet below the crown. Slide gate in a 36-inch corrugated metal pipe (CMP) riser on the waterside (WS) slope. Drainage canal off the landside (LS) toe. This pipe replaced a 15-inch pipe at the same location. [Additional Reference(s): DWR Levee Log, 2005. USACE San Joaquin O&M Manual 4, June 1968, (HLM 0.57)].					
FS Date: 9/11/2013

Slide gate in CMP riser on WS shoulder.

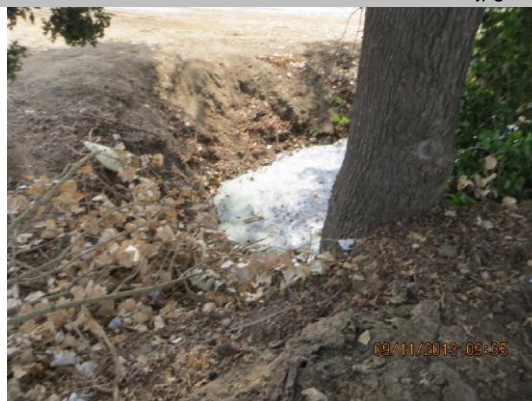
Photo 3 of 3 : UCIP\_FA\_2019\_20044\_33940.jpg

Drainage ditch at inlet on LS toe.

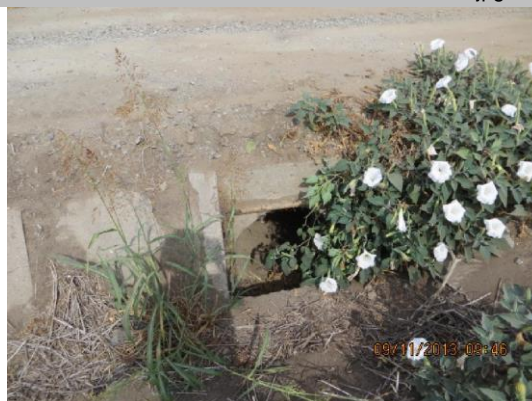
Photo 1 of 3 : UCIP\_FA\_2019\_20046\_33946.jpg

LM Start	0.72	Rating **	M	Issue No.	975
LM End	0.72	Issue Type +	En	Location *	
Category	Supplemental			GPS Latitude/Longitude	
				Start	End
Item	DRAFT DWR UCIP Field Study			37.701912 °	37.701912 °
				-121.161642 °	-121.161642 °
DWR ID	20440				
Comment Code					
Inspector Comment					
DS_ID:20440 FS_ID:20046 EP_NO: N/A Repair Type: Non-Urgent Crossing Status: Found UCIP Comments: Alfalfa valve on the WS toe is damaged. FIELD_STRUCT_DESC: 30-inch corrugated metal irrigation pipe through the levee, 5 feet below the crown. Flashboard slots in concrete headwall on the landside (LS). Distribution box with an alfalfa valve on the waterside (WS). Installed by USACE in 1966. Replaced a 30-inch pipe at the same location. [Additional Reference(s): DWR Levee Log, 2005. USACE San Joaquin O&M Manual 4, June 1968]. FS Date: 9/11/2013

Concrete headwall and pipe at concrete channel along landside shoulder of levee.

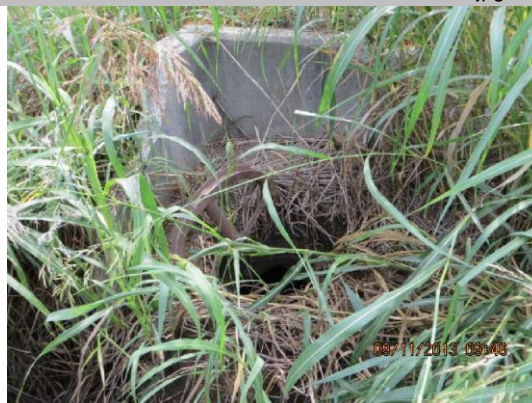
Photo 2 of 3 : UCIP\_FA\_2019\_20046\_33945.jpg

Concrete headwall and damaged alfalfa valve on WS toe.

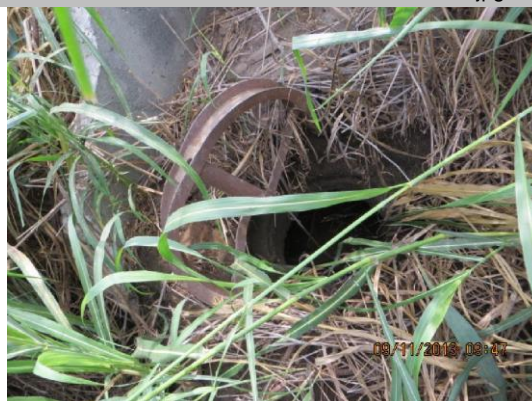
Photo 3 of 3 : UCIP\_FA\_2019\_20046\_33944.jpg

Damaged alfalfa valve.

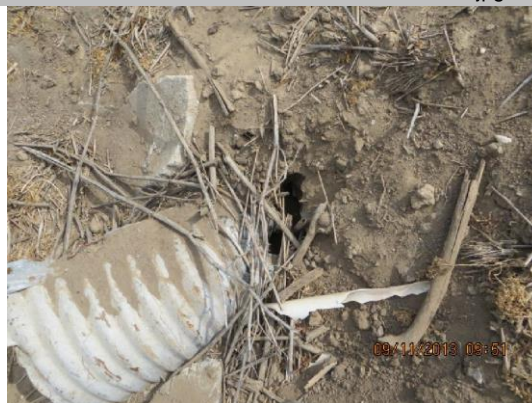
Photo 2 of 3 : UCIP\_FA\_2019\_20047\_33949.jpg

LM Start	0.75	Rating **	M	Issue No.	976
LM End	0.75	Issue Type +	En	Location *	
Category	Supplemental			GPS Latitude/Longitude	
				Start	End
Item	DRAFT DWR UCIP Field Study			37.701552°	37.701552°
				-121.161883°	-121.161883°
DWR ID	20441				
Comment Code					
Inspector Comment					
DS_ID:20441 FS_ID:20047 EP_NO: N/A Repair Type: Non-Urgent Crossing Status: Found UCIP Comments: This pipe appears abandoned and if so, should be done so appropriately. FIELD_STRUCT_DESC: 15-inch corrugated metal irrigation pipe through the levee, 4 feet below the crown. Flashboard slots on the landside (LS). Installed by USACE in 1966. [Additional Reference(s): DWR Levee Log, 2005. USACE San Joaquin O&M Manual 4, June 1968, (HLM 0.75)]. FS Date: 9/11/2013

Hole in pipe at WS slope.

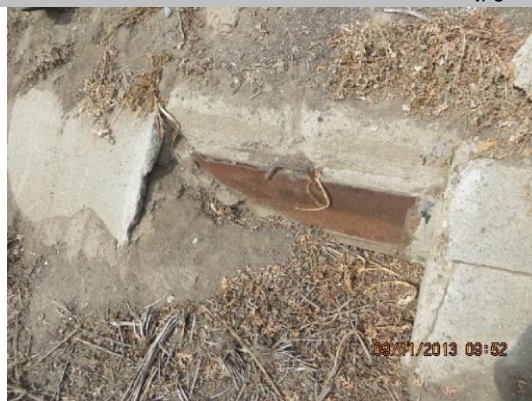
Photo 3 of 3 : UCIP\_FA\_2019\_20047\_33948.jpg

Closed slidegate at concrete headwall in concrete channel on LS shoulder.

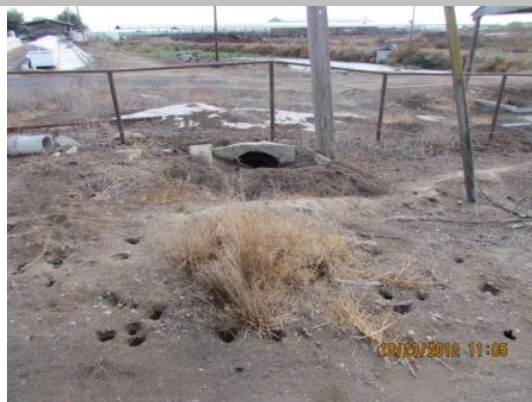
Photo 1 of 1 : FA\_2019\_RD2031\_307\_36\_20190830\_00009.jpg

LM Start	0.77	Rating **	M	Issue No.	36
LM End	0.77	Issue Type +	Ma	Location *	LS
Category	Earthen Levee			GPS Latitude/Longitude	
				Start	End
Item	Animal Control			37.701177 °	37.701177 °
				-121.162055 °	-121.162055 °
DWR ID	DWR_RD2031_01_f_2012_36				
Comment Code					
A3 : No rodents visible, but rodent burrows visible; need to backfill and compact or grout burrows.					
Inspector Comment

View of rodent burrows on landside slope.

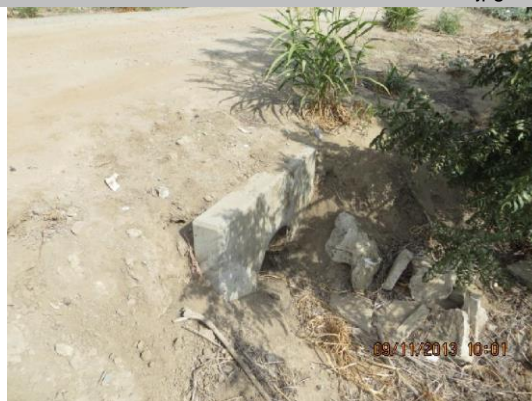
Photo 1 of 3 : UCIP\_FA\_2019\_20049\_33956.jpg

LM Start	0.80	Rating **	M	Issue No.	977
LM End	0.80	Issue Type +	En	Location *	
Category	Supplemental			GPS Latitude/Longitude	
				Start	End
Item	DRAFT DWR UCIP Field Study			37.700853 °	37.700853 °
				-121.162349 °	-121.162349 °
DWR ID	20443				
Comment Code					
Inspector Comment					
DS_ID:20443					
FS_ID:20049					
EP_NO: N/A					
Repair Type: Non-Urgent					
Crossing Status: Found					
UCIP Comments: Pipe appears abandoned as WS slope is covered with soil. If abandoned, it should be done so properly.					
FIELD_STRUCT_DESC: 24-inch steel irrigation pipe through the levee, 2 feet below the crown. Concrete headwalls on both sides of the levee crown. [Additional Reference(s): DWR Levee Log, 2005. USACE San Joaquin O&M Manual 4, June 1968, (HLM 0.81)].					
FS Date: 9/11/2013

Open pipe and headwall on LS slope.

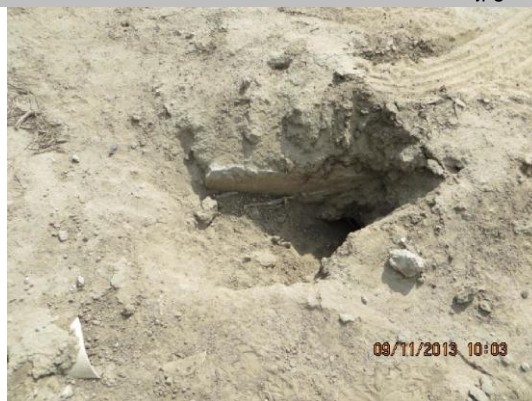
Photo 3 of 3 : UCIP\_FA\_2019\_20049\_33954.jpg

Concrete headwall on WS shoulder buried.

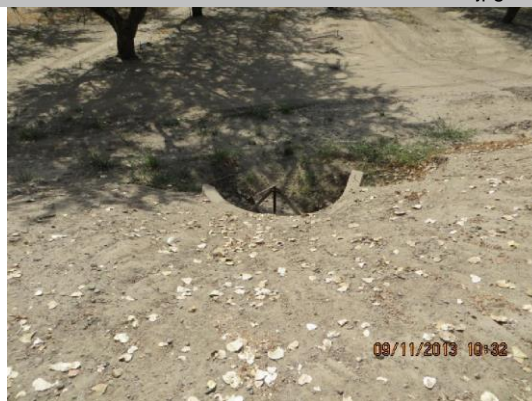
Photo 1 of 3 : UCIP\_FA\_2019\_47158\_74940.jpg

LM Start	0.92	Rating **	M	Issue No.	978
LM End	0.92	Issue Type +	En	Location *	
Category	Supplemental			GPS Latitude/Longitude	
				Start	End
Item	DRAFT DWR UCIP Field Study			37.699692 °	37.699692 °
				-121.163977 °	-121.163977 °
DWR ID	20444				
Comment Code					
Inspector Comment					
DS_ID:20444 FS_ID:47158 EP_NO: N/A Repair Type: Non-Urgent Crossing Status: Indicator Found UCIP Comments: Need site visit by UCIP--Concrete headwall present on landward side toe. Need to coordinate with owner to determine if this headwall is for 24-inch pipe or if the structure is part of drainage system that could run parallel to levee. FIELD_STRUCT_DESC: 24-inch drainage pipe of an unknown material through the levee, 3.5 feet below the crown. Flap gate on the waterside (WS) end. [Additional Reference(s): DWR Levee Log, 2005]. FS Date: 9/10/2013

Concrete structure located on landward side toe.

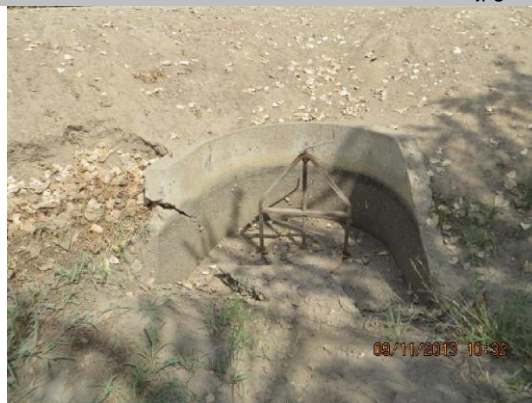
Photo 2 of 3 : UCIP\_FA\_2019\_47158\_74941.jpg

Front view of concrete structure located on landward side toe.

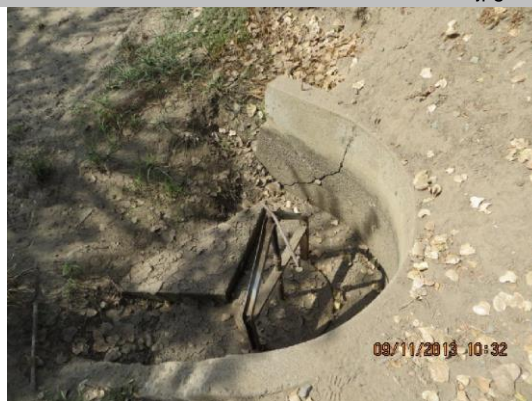
Photo 3 of 3 : UCIP\_FA\_2019\_47158\_74942.jpg

Structure buried with soil--no access.

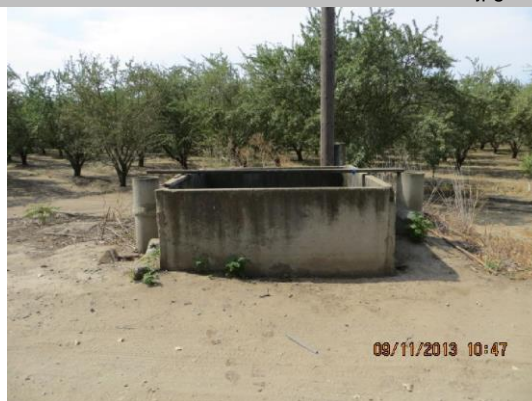
Photo 1 of 3 : UCIP\_FA\_2019\_20085\_34010.jpg

LM Start	<b>1.27</b>	Rating **	M	Issue No.	<b>979</b>
LM End	<b>1.27</b>	Issue Type +	En	Location *	
Category	Supplemental		GPS Latitude/Longitude		
			Start	End	
Item	DRAFT DWR UCIP Field Study		37.699480°	37.699480°	
			-121.169850°	-121.169850°	
DWR ID	20445				
Comment Code					
Inspector Comment					
DS_ID:20445 FS_ID:20085 EP_NO: N/A Repair Type: Non-Urgent Crossing Status: Found UCIP Comments: Pipe corroded through at distribution box. Appears abandoned and should be done so properly. FIELD_STRUCT_DESC: 1 of 2: 12-inch steel irrigation pipe through the levee, 3.3 feet below the crown. Pump missing from pile structure on the riverbank. Concrete distribution box on the landside (LS). Installed by USACE in 1966. [Additional Reference(s): DWR Levee Log, 2005. USACE San Joaquin O&M Manual 4, June 1968, (HLM 1.28)]. FS Date: 9/11/2013

Concrete distribution box on LS shoulder.

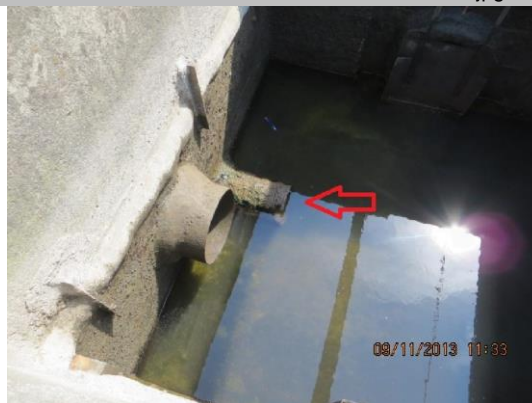
Photo 3 of 3 : UCIP\_FA\_2019\_20085\_34008.jpg

Pipe visible inside concrete distribution box on LS shoulder.

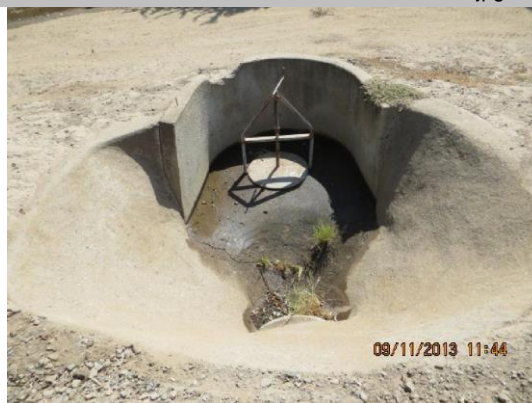
Photo 1 of 3 : UCIP\_FA\_2019\_20088\_34030.jpg

LM Start	1.55	Rating **	A/W	Issue No.	980
LM End	1.55	Issue Type +	Ma	Location *	
Category	Supplemental			GPS Latitude/Longitude	
				Start	End
Item	DRAFT DWR UCIP LMA Responsibility			37.698921°	37.698921°
				-121.174144°	-121.174144°
DWR ID	20446				
Comment Code					
Inspector Comment					
DS_ID:20446					
FS_ID:20088					
EP_NO: N/A					
Repair Type: No Action Needed					
Crossing Status: Found					
UCIP Comments:					
FIELD_STRUCT_DESC: 24-inch corrugated metal drainage pipe through the levee, 3.5 feet below the crown. Concrete headwalls on both ends. Flap gate on the waterside (WS) end. Installed by USACE in 1966. [Additional Reference(s): DWR Levee Log, 2005. USACE San Joaquin O&M Manual 4, June 1968, (HLM 1.56)].					
FS Date: 9/11/2013

Bowl shaped concrete inlet on LS slope.

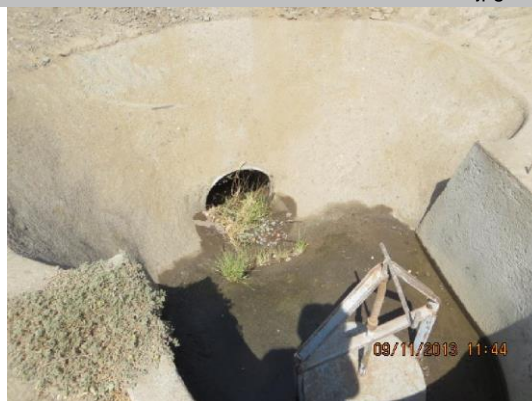
Photo 2 of 3 : UCIP\_FA\_2019\_20088\_34029.jpg

Bowl shaped concrete inlet on LS slope.

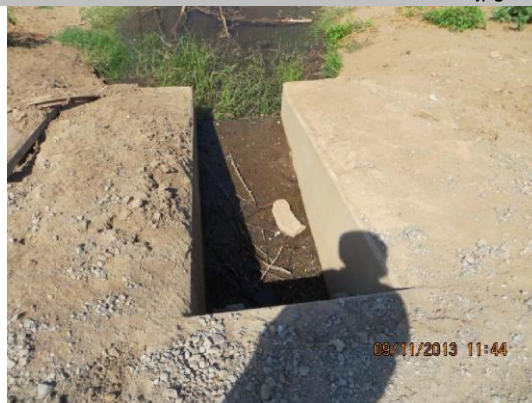
Photo 3 of 3 : UCIP\_FA\_2019\_20088\_34028.jpg

Concrete U-shaped headwall on WS slope.

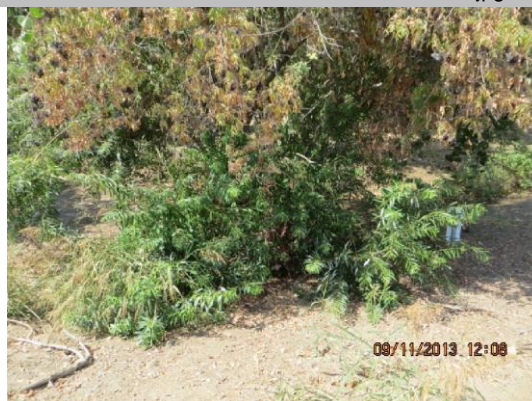
Photo 2 of 3 : UCIP\_FA\_2019\_20110\_34077.jpg

Vegetation covers outlet of pipe on WS slope.

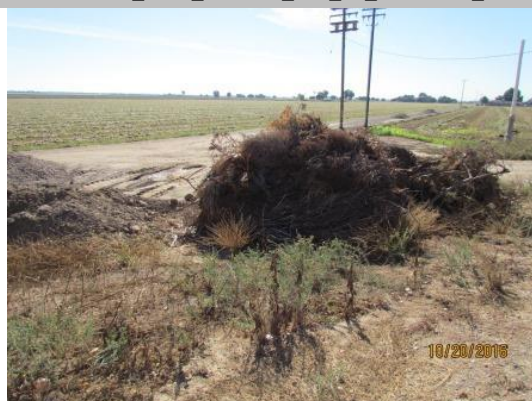
Photo 2 of 2 : FA\_2019\_RD2031\_307\_53\_20190830\_00017.jpg

View of another debris pile in close proximity of the previous photo.

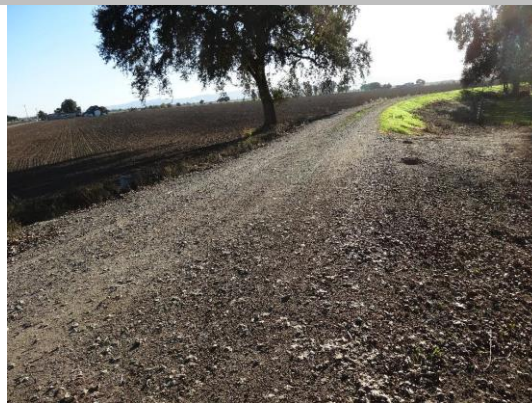
Photo 2 of 3 : UCIP\_FA\_2019\_51340\_76567.jpg

Overview of levee crown where pipe should cross levee. Limited access on WS due to fence.

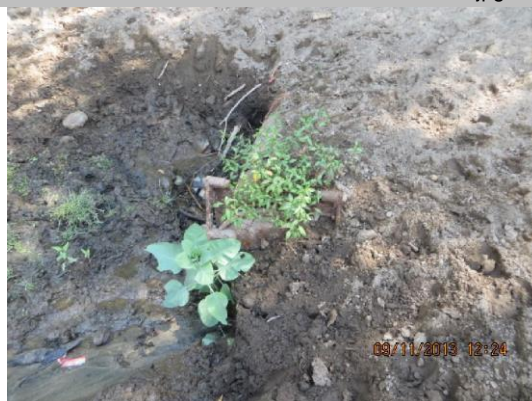
Photo 3 of 3 : UCIP\_FA\_2019\_51340\_39001.jpg

Flapgate partially blocked by soil on WS toe.

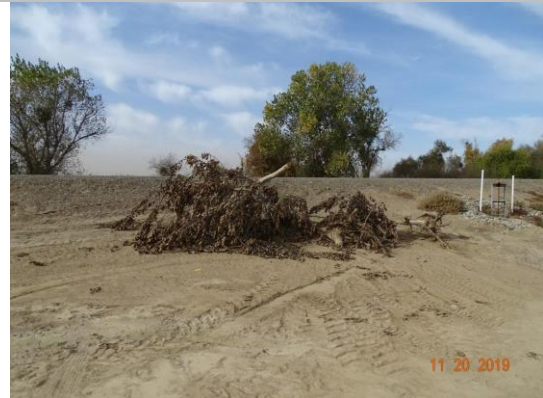
Photo 1 of 1 : FA\_2019\_RD2031\_308\_17\_20191120\_00043.jpg

View of prunings on landside easement. Fall 2019

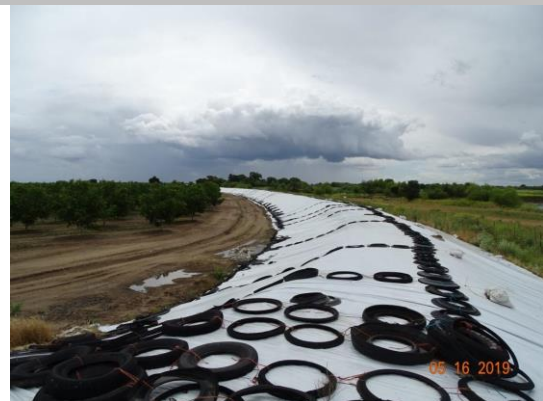
Photo 1 of 4 : FA\_2019\_RD2031\_308\_16\_20190830\_00005.jpg

View of visqueen on crown and landside slope installed in 2017. (Spring 2019)

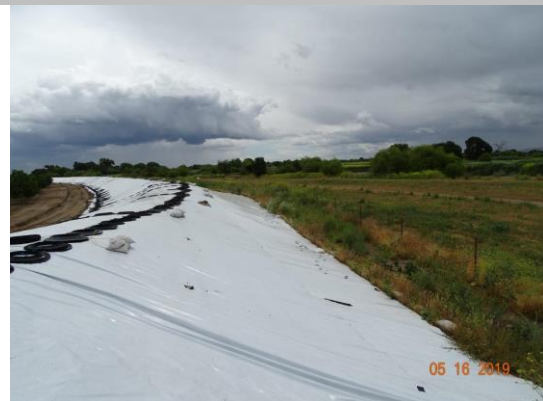
Photo 2 of 4 : FA\_2019\_RD2031\_308\_16\_20190830\_00006.jpg

View of visqueen on crown and waterside slope installed in 2017. (Spring 2019)

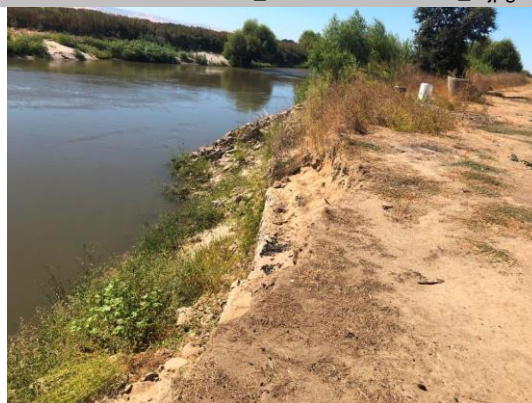
Photo 2 of 3 : SJR2019\_RD2031U02RM78.7\_4.jpg

Looking downstream of the erosion site.

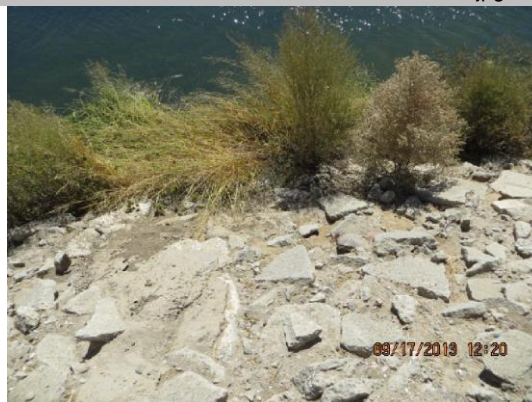
Photo 2 of 3 : UCIP\_FA\_2019\_22872\_39035.jpg

Concrete debris placed over pipe location on WS shoulder.
